The Martian Landscape

By The Viking Lander Imaging Team

Scientific and Technical Information Office
NATIONAL AERONAUTICS AND SPACE ADMINISTRATION
Washington, D.C. 1978

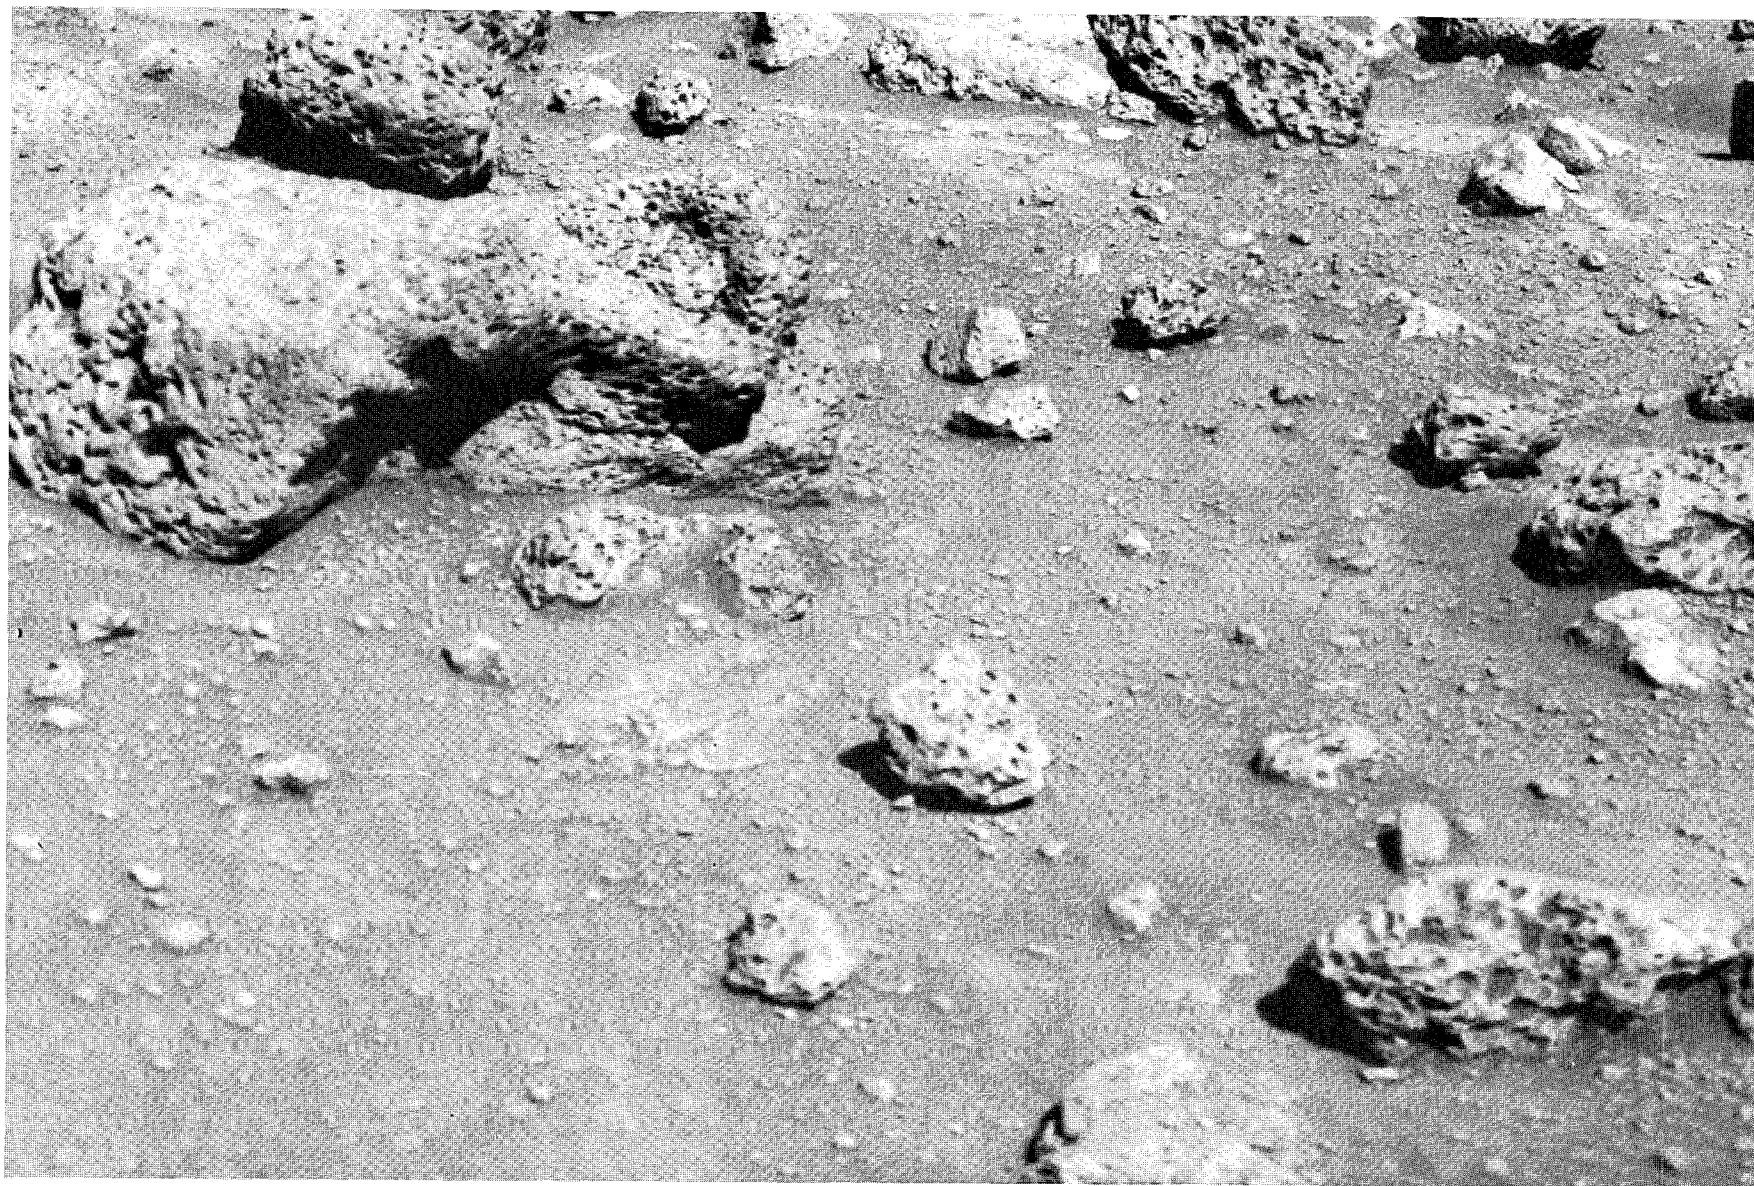
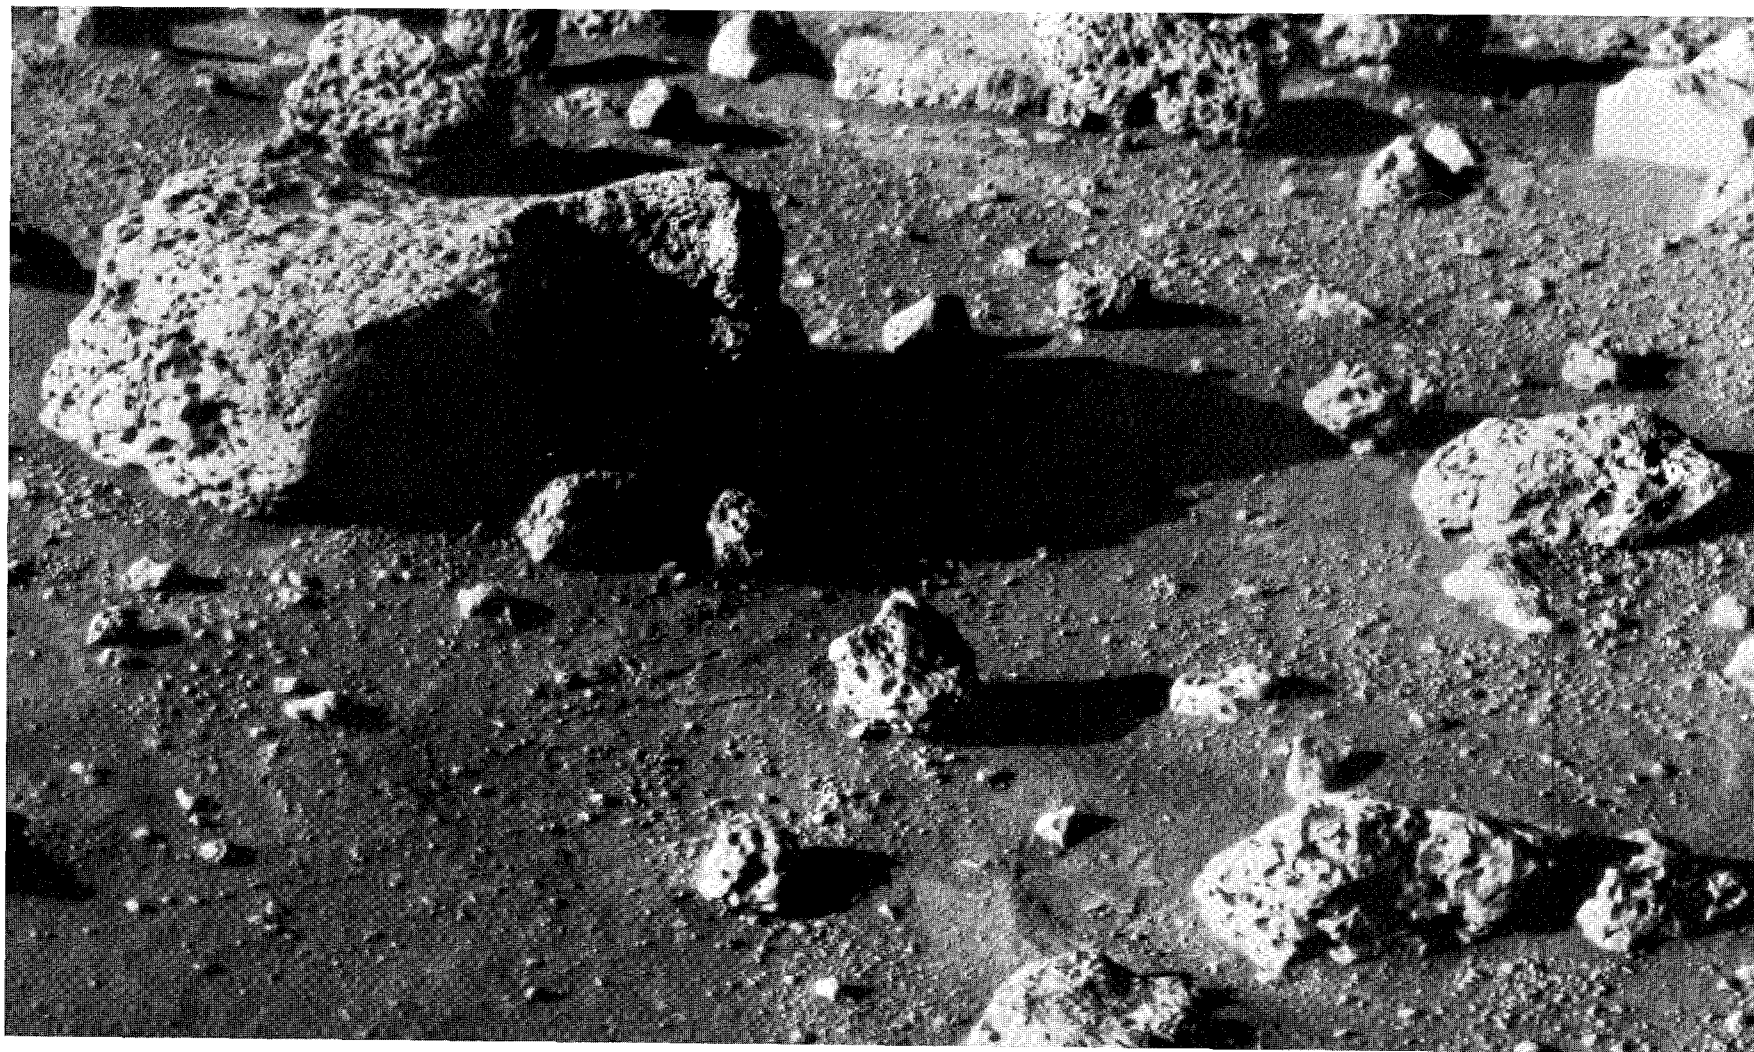
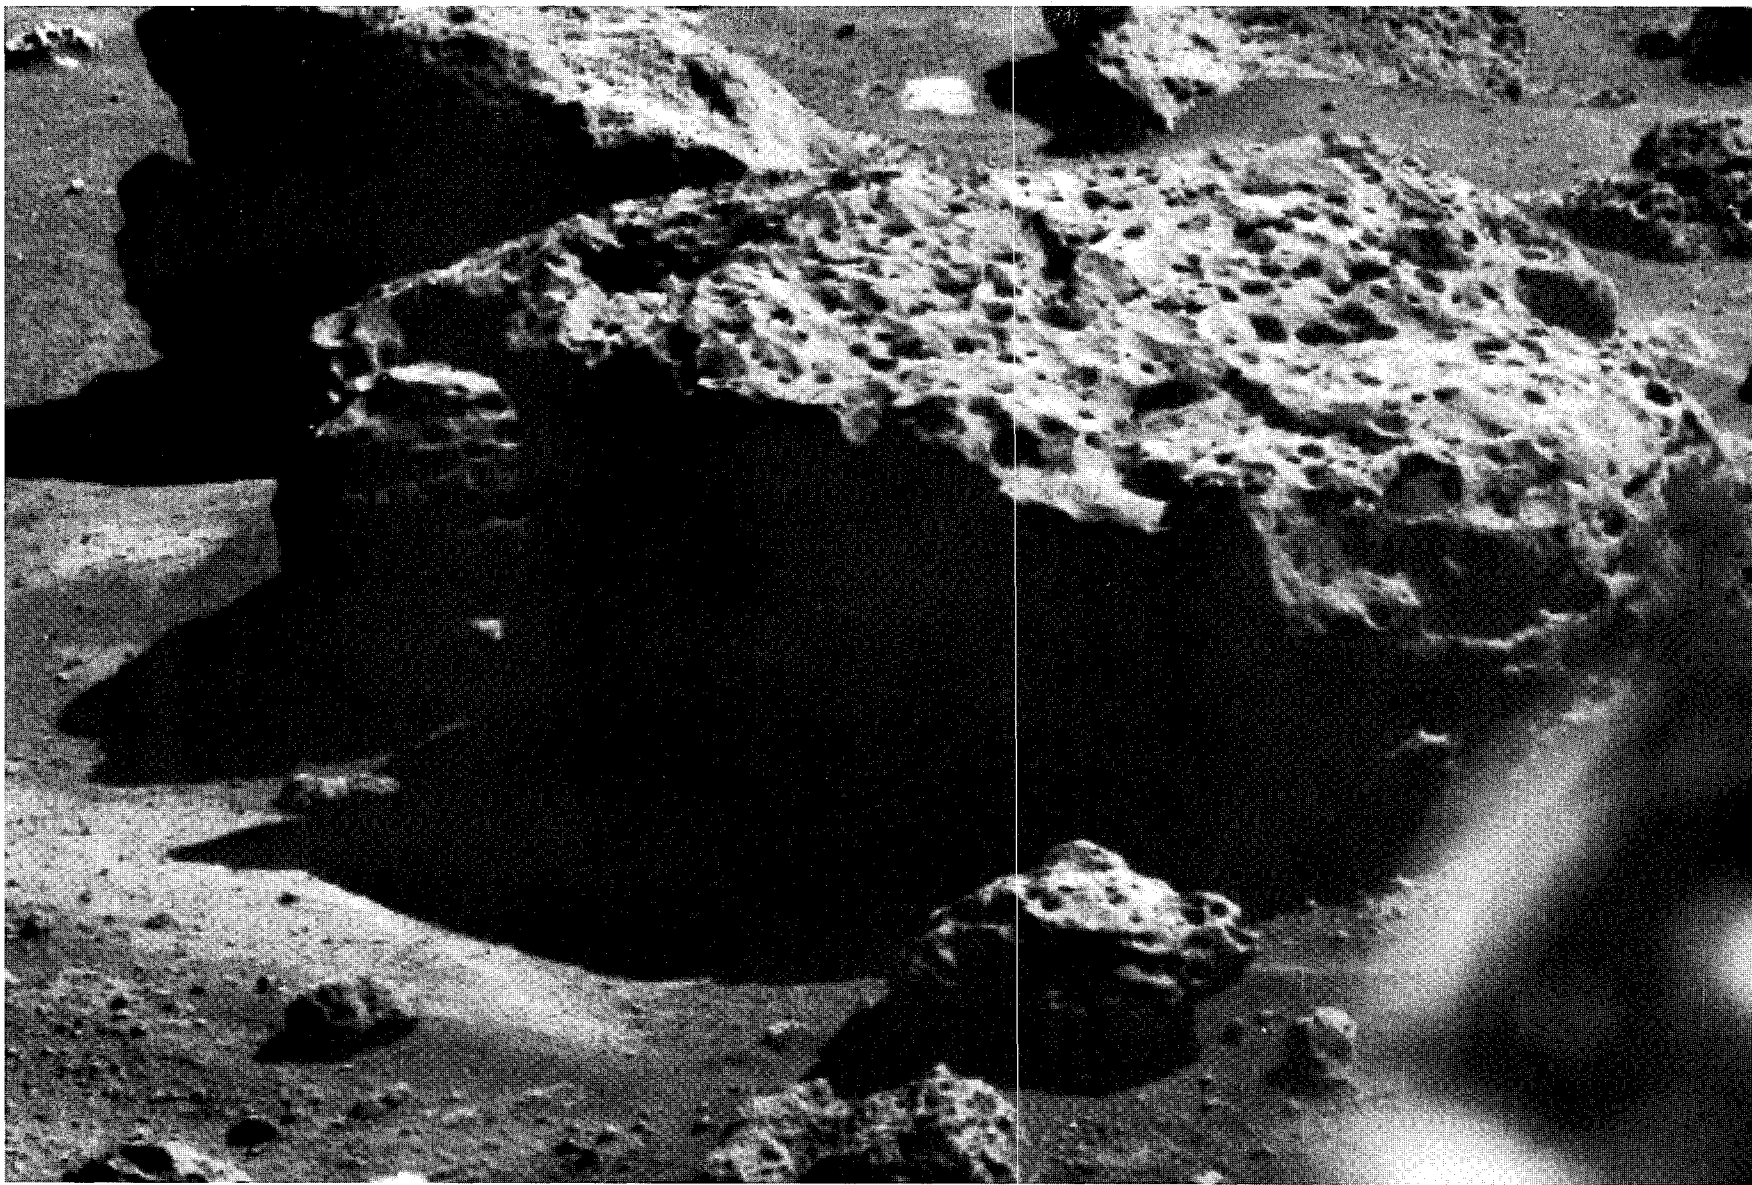
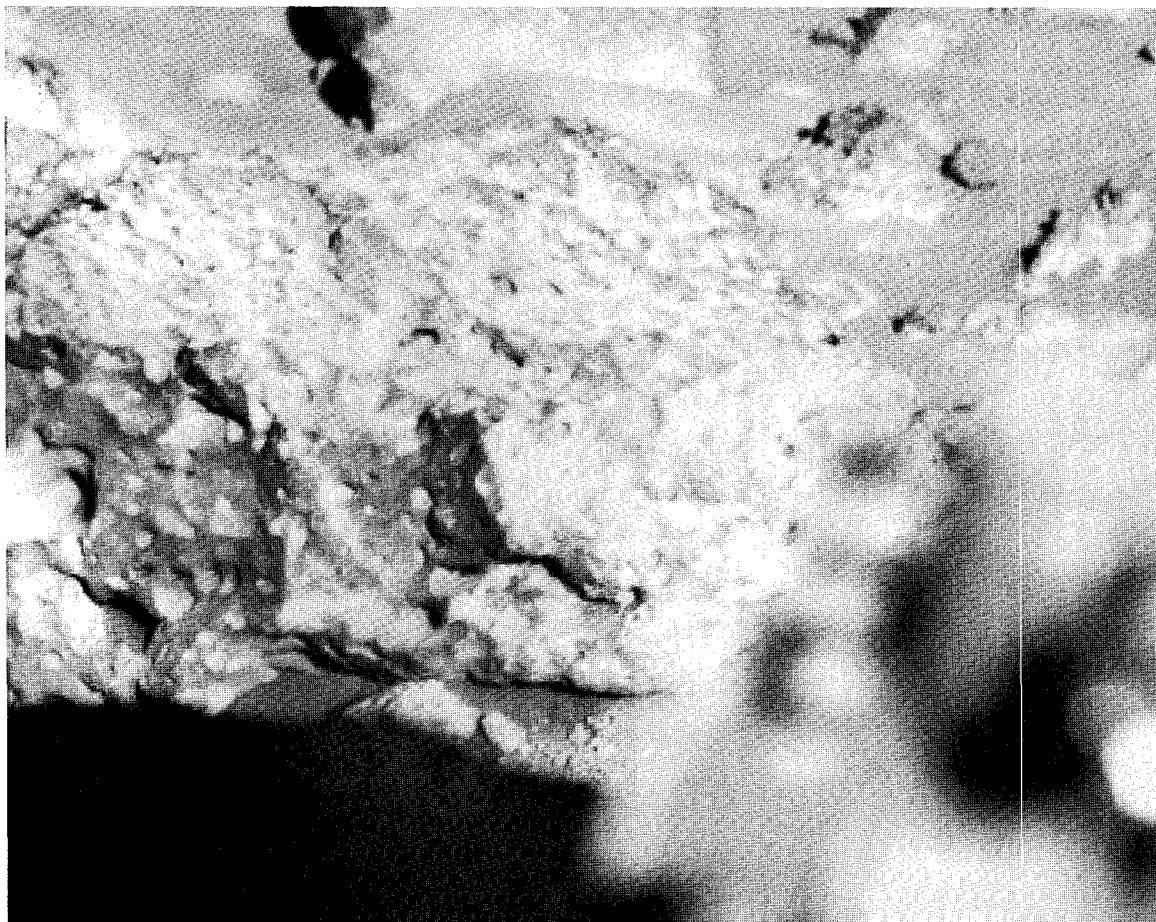
Figures 118 to 121 make up two pairs of pictures with different illumination angles. Because of their roughly textured and pitted surfaces, the blocks change dramatically in appearance as the lighting varies from direct to oblique.

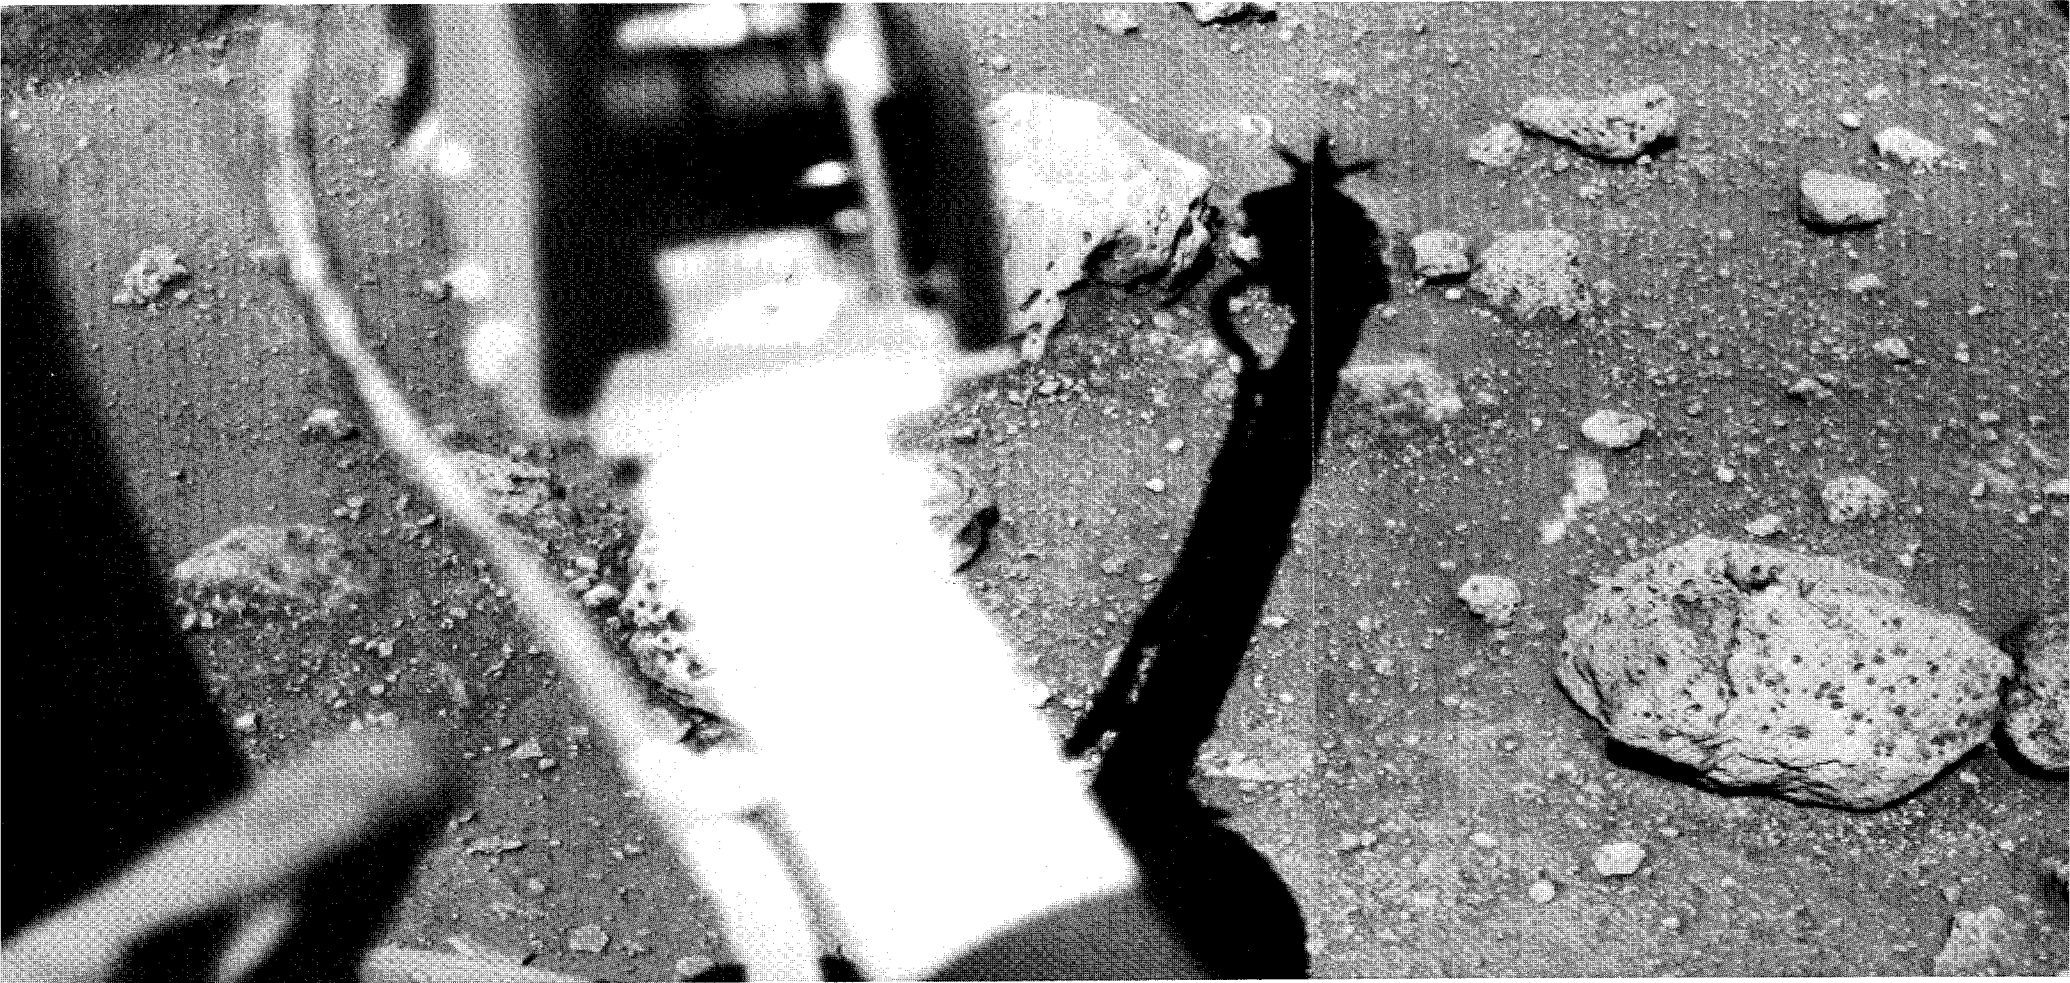
FIGURE 122

Figure 122 is a 100° panorama taken in the late afternoon. The lower part of the meteorology boom appears to the left; the shadow of the upper mast, including sensors, is visible immediately to the right. Figure 122 includes a region from -30° to -50° in camera elevation. Figure 123 is from -40° to -60° , so that a rock that appears in the lower far right of figure 122 is located in the upper left of figure 123.

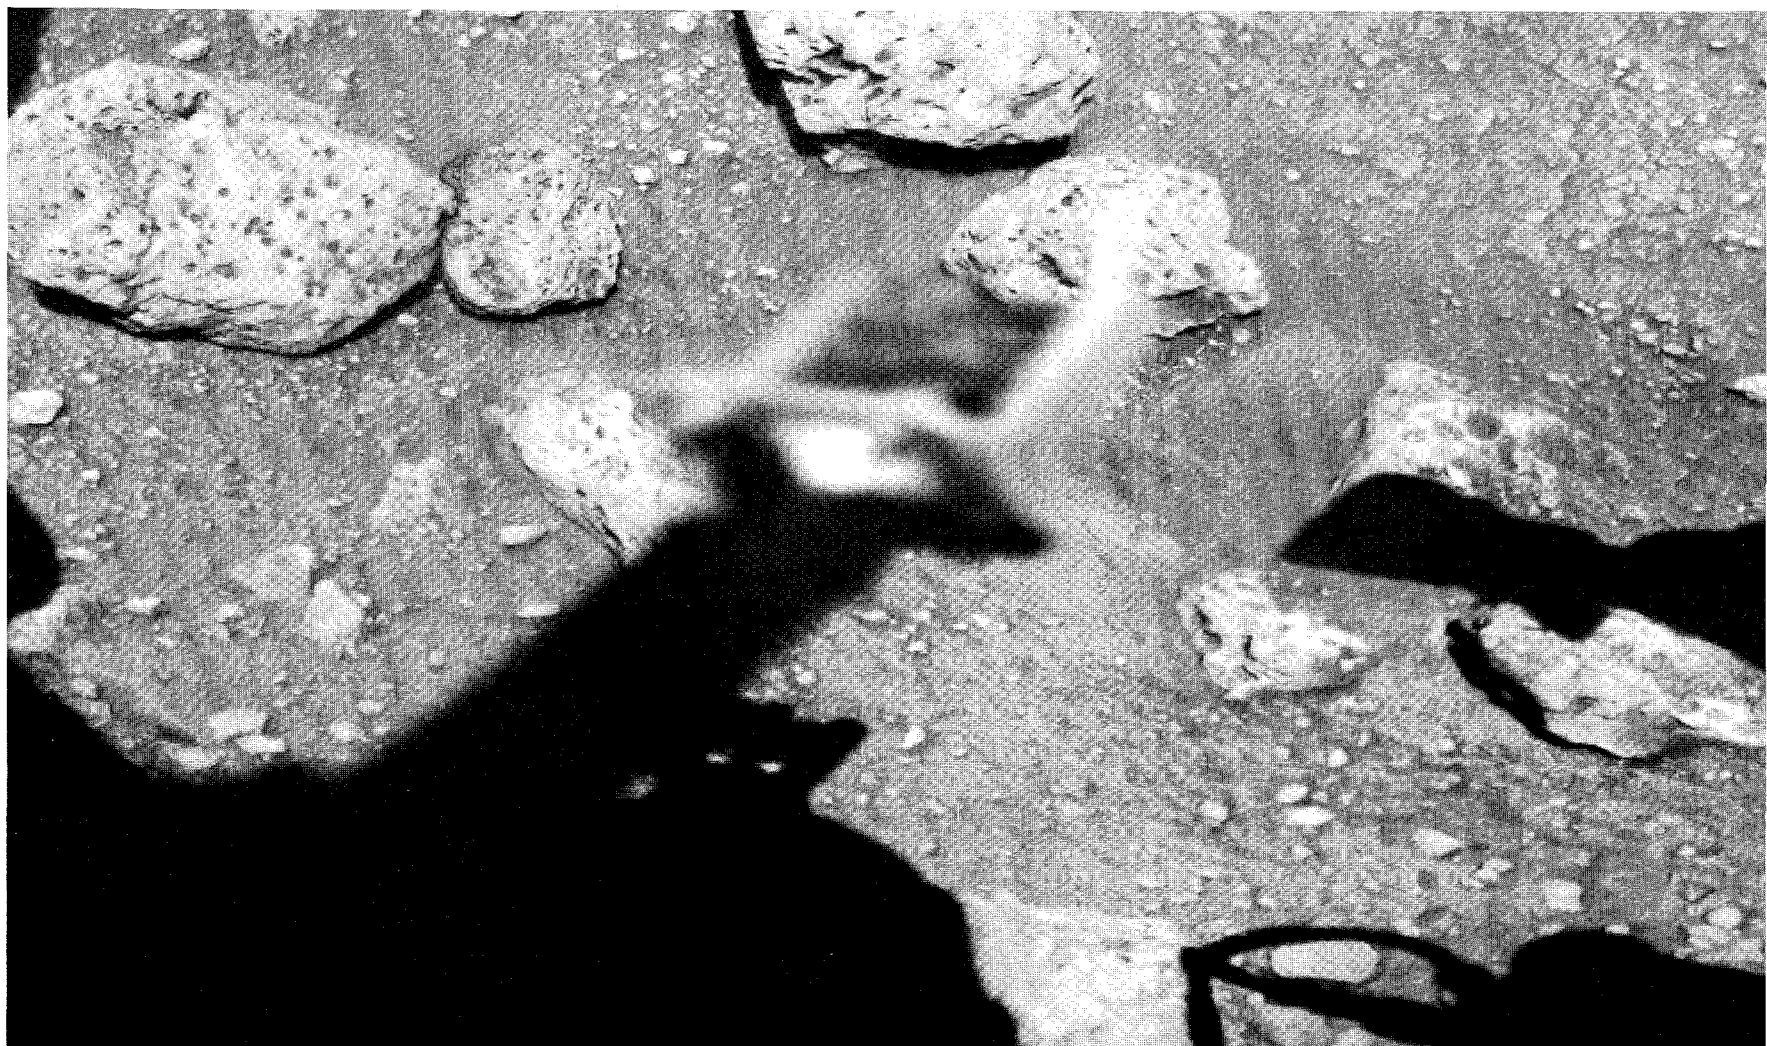
FIGURE 124

These three figures show the effects of erosion in the vicinity of the descent engine exhaust impact point. A thin veneer of fine-grained sediment has been swept away to reveal polygonally fractured "rock." In fact, the polygonal fragments probably represent cemented soil fragments. This inference is strengthened by the observation that chemical analyses of unconsolidated soil

The prominent structure in figures 124 and 125 is the magnet-cleaning brush. Mounting brackets for the surface sampler assembly appear at the left in figure 126.

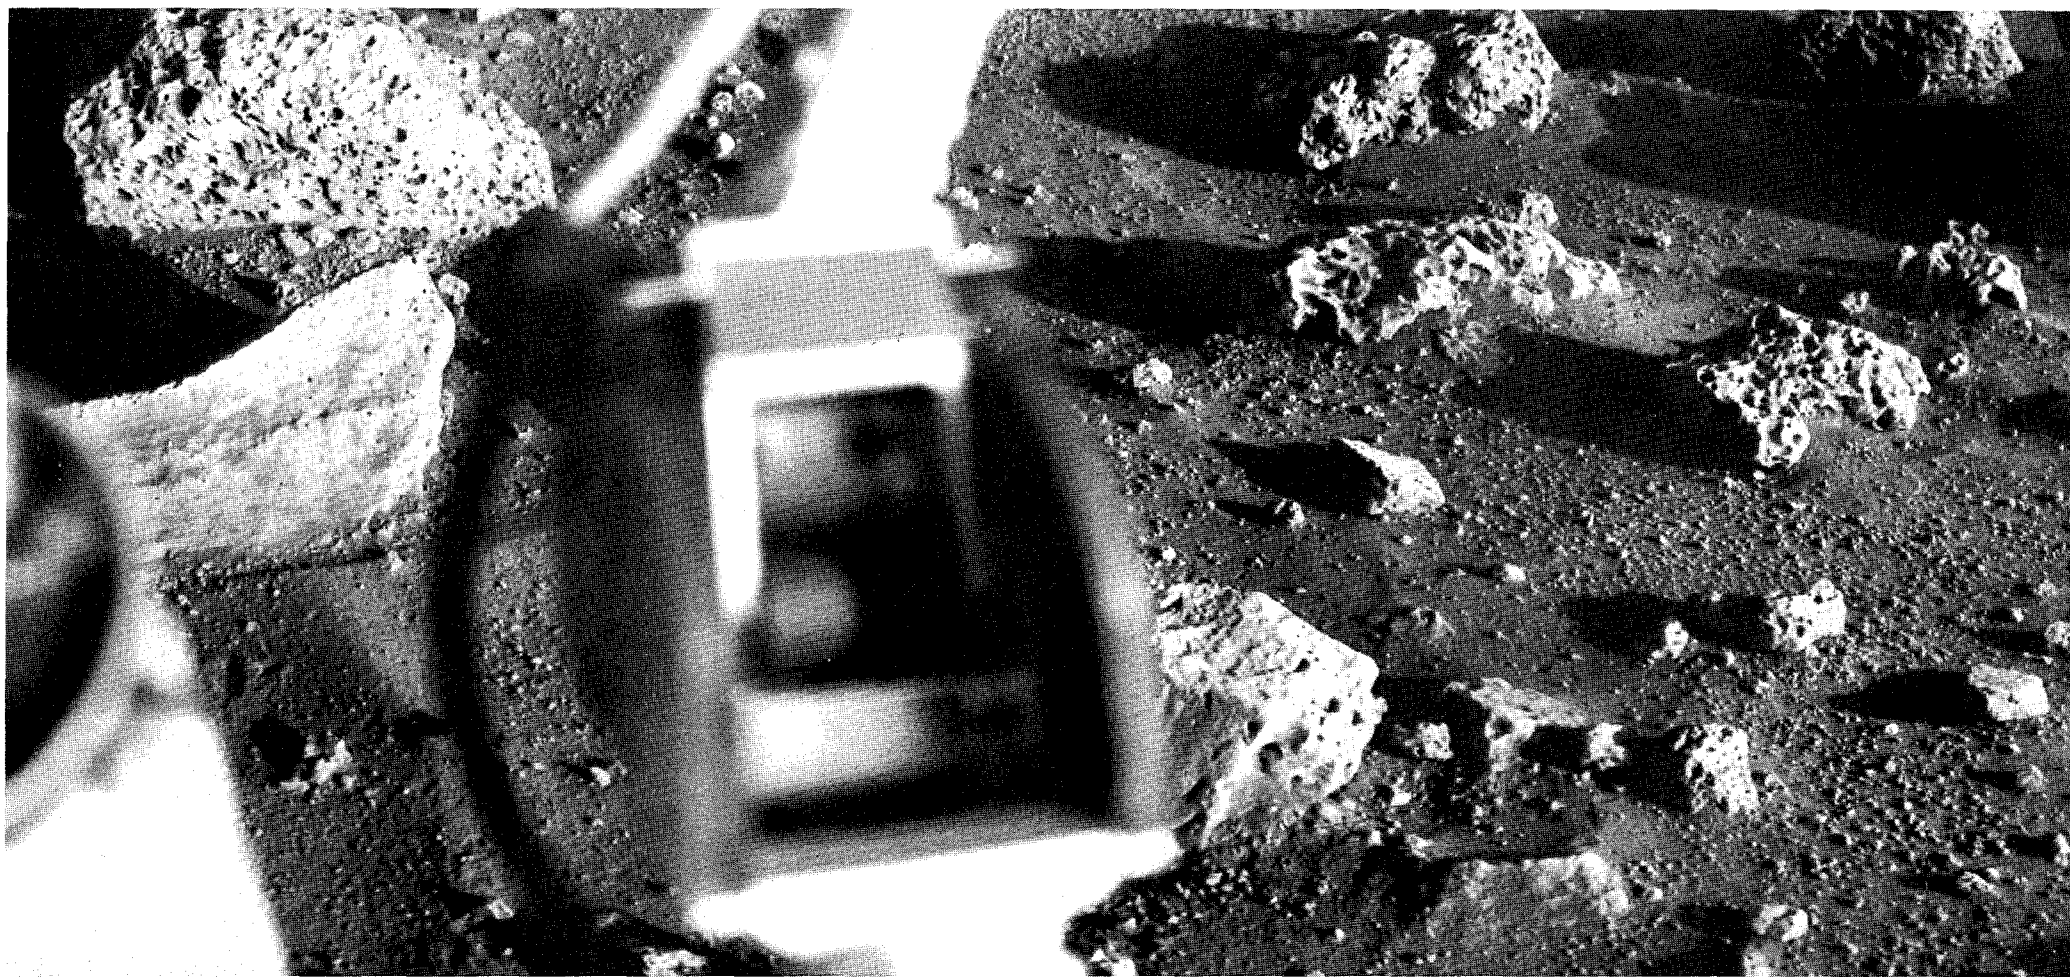
FIGURE 127

Two views of rocks and sediment at the Viking 2 site. Fillets of sediment that partly bury some blocks are shown well in figure 127. The grazing early-morning light accentuates parallel grooves in the large block at the center of figure 129. This stratification might have been caused by flow in a viscous volcanic lava.

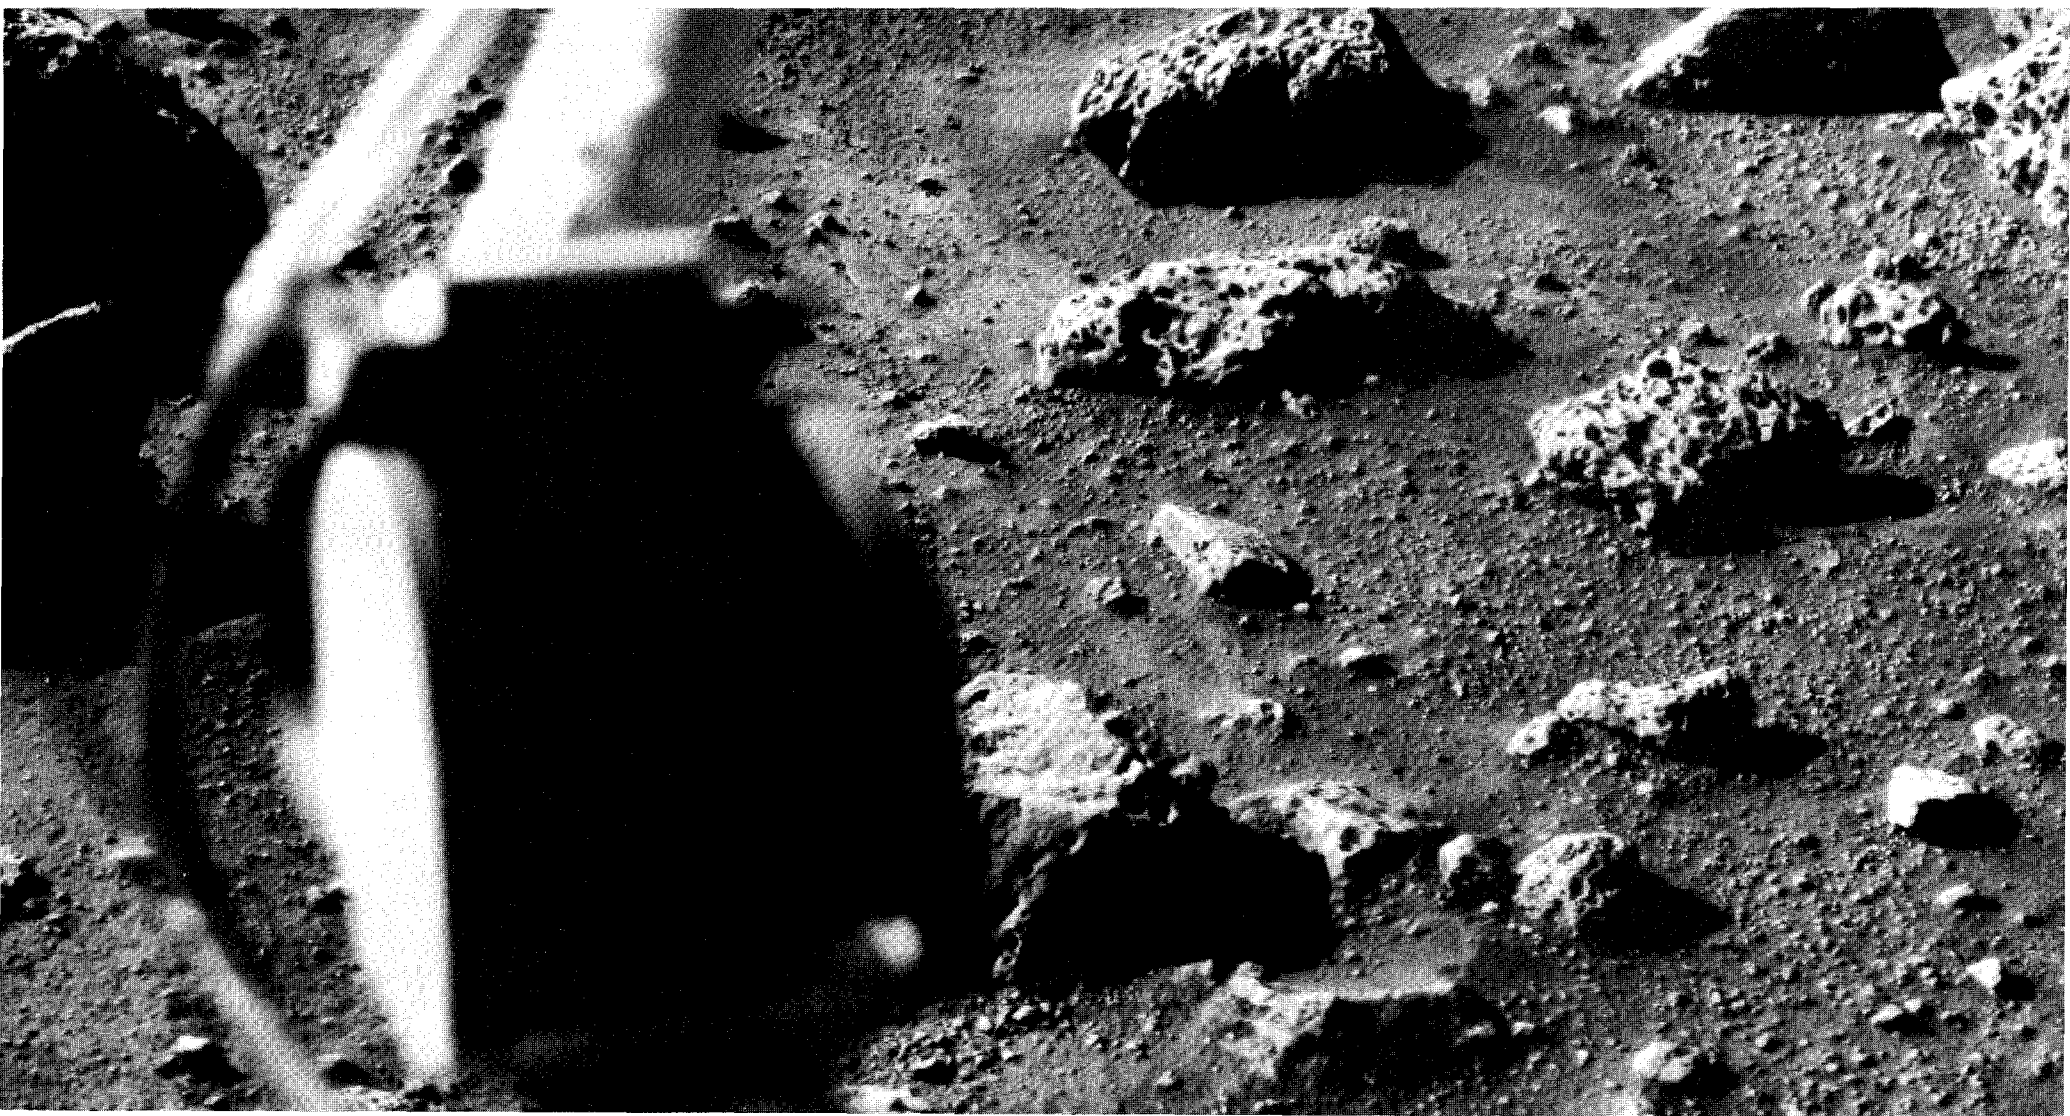
FIGURE 128

Approximately vertical illumination in figure 128 brings out differences in soil texture. The finer-grained material appears to be a patchy wind deposit superposed on coarser accumulations of cemented soil fragments. The surface sampler has been unable to acquire any of these coarser fragments which apparently disintegrate when scooped up.

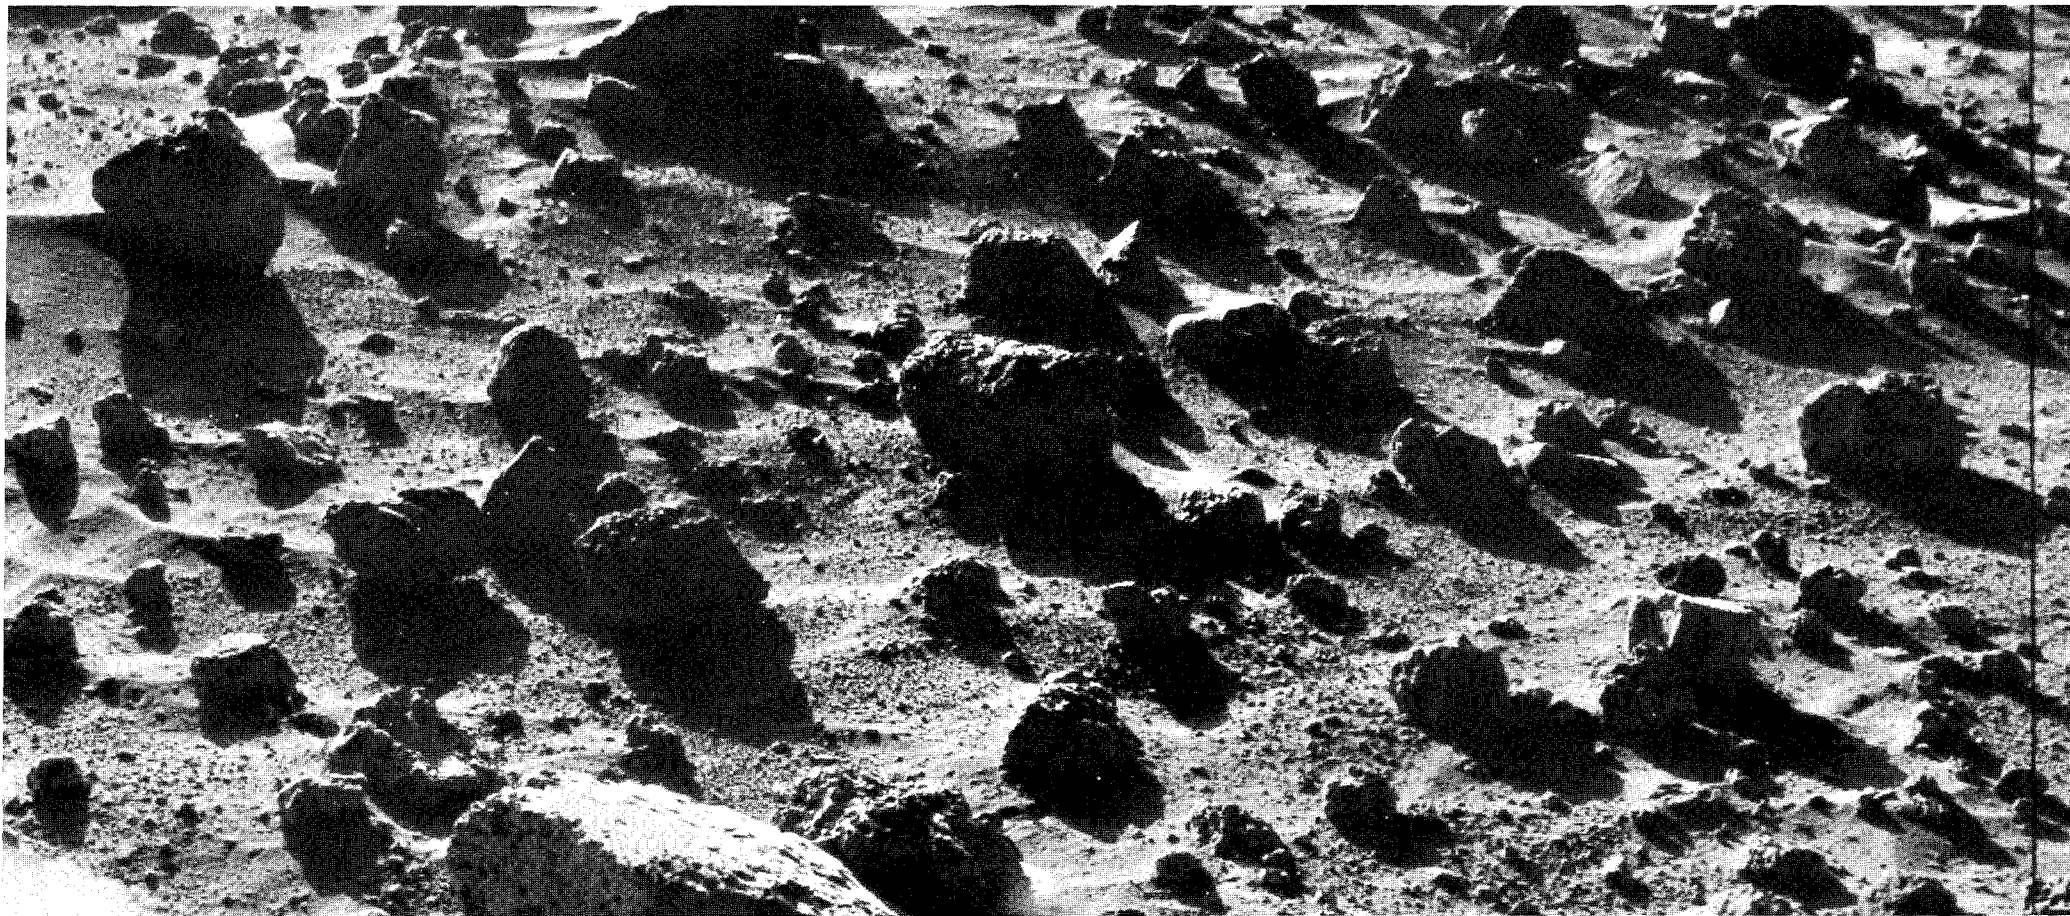
FIGURE 130

Three views of the same area were taken in late afternoon (fig. 130), early morning (fig. 131), and midday (fig. 132). The appearance of the scene changes dramatically with the change in illumination. Although many of the blocks have the pitted appearance characteristic of the Viking 2 site, some are clearly different in morphology and, perhaps, chemical composition. Look, for example, at the smoothly polished block that

appears a little to the right of center in figure 132. Its singular appearance is more subtly revealed in figures 130 and 131. In the first case, a smooth face reflects the evening light.

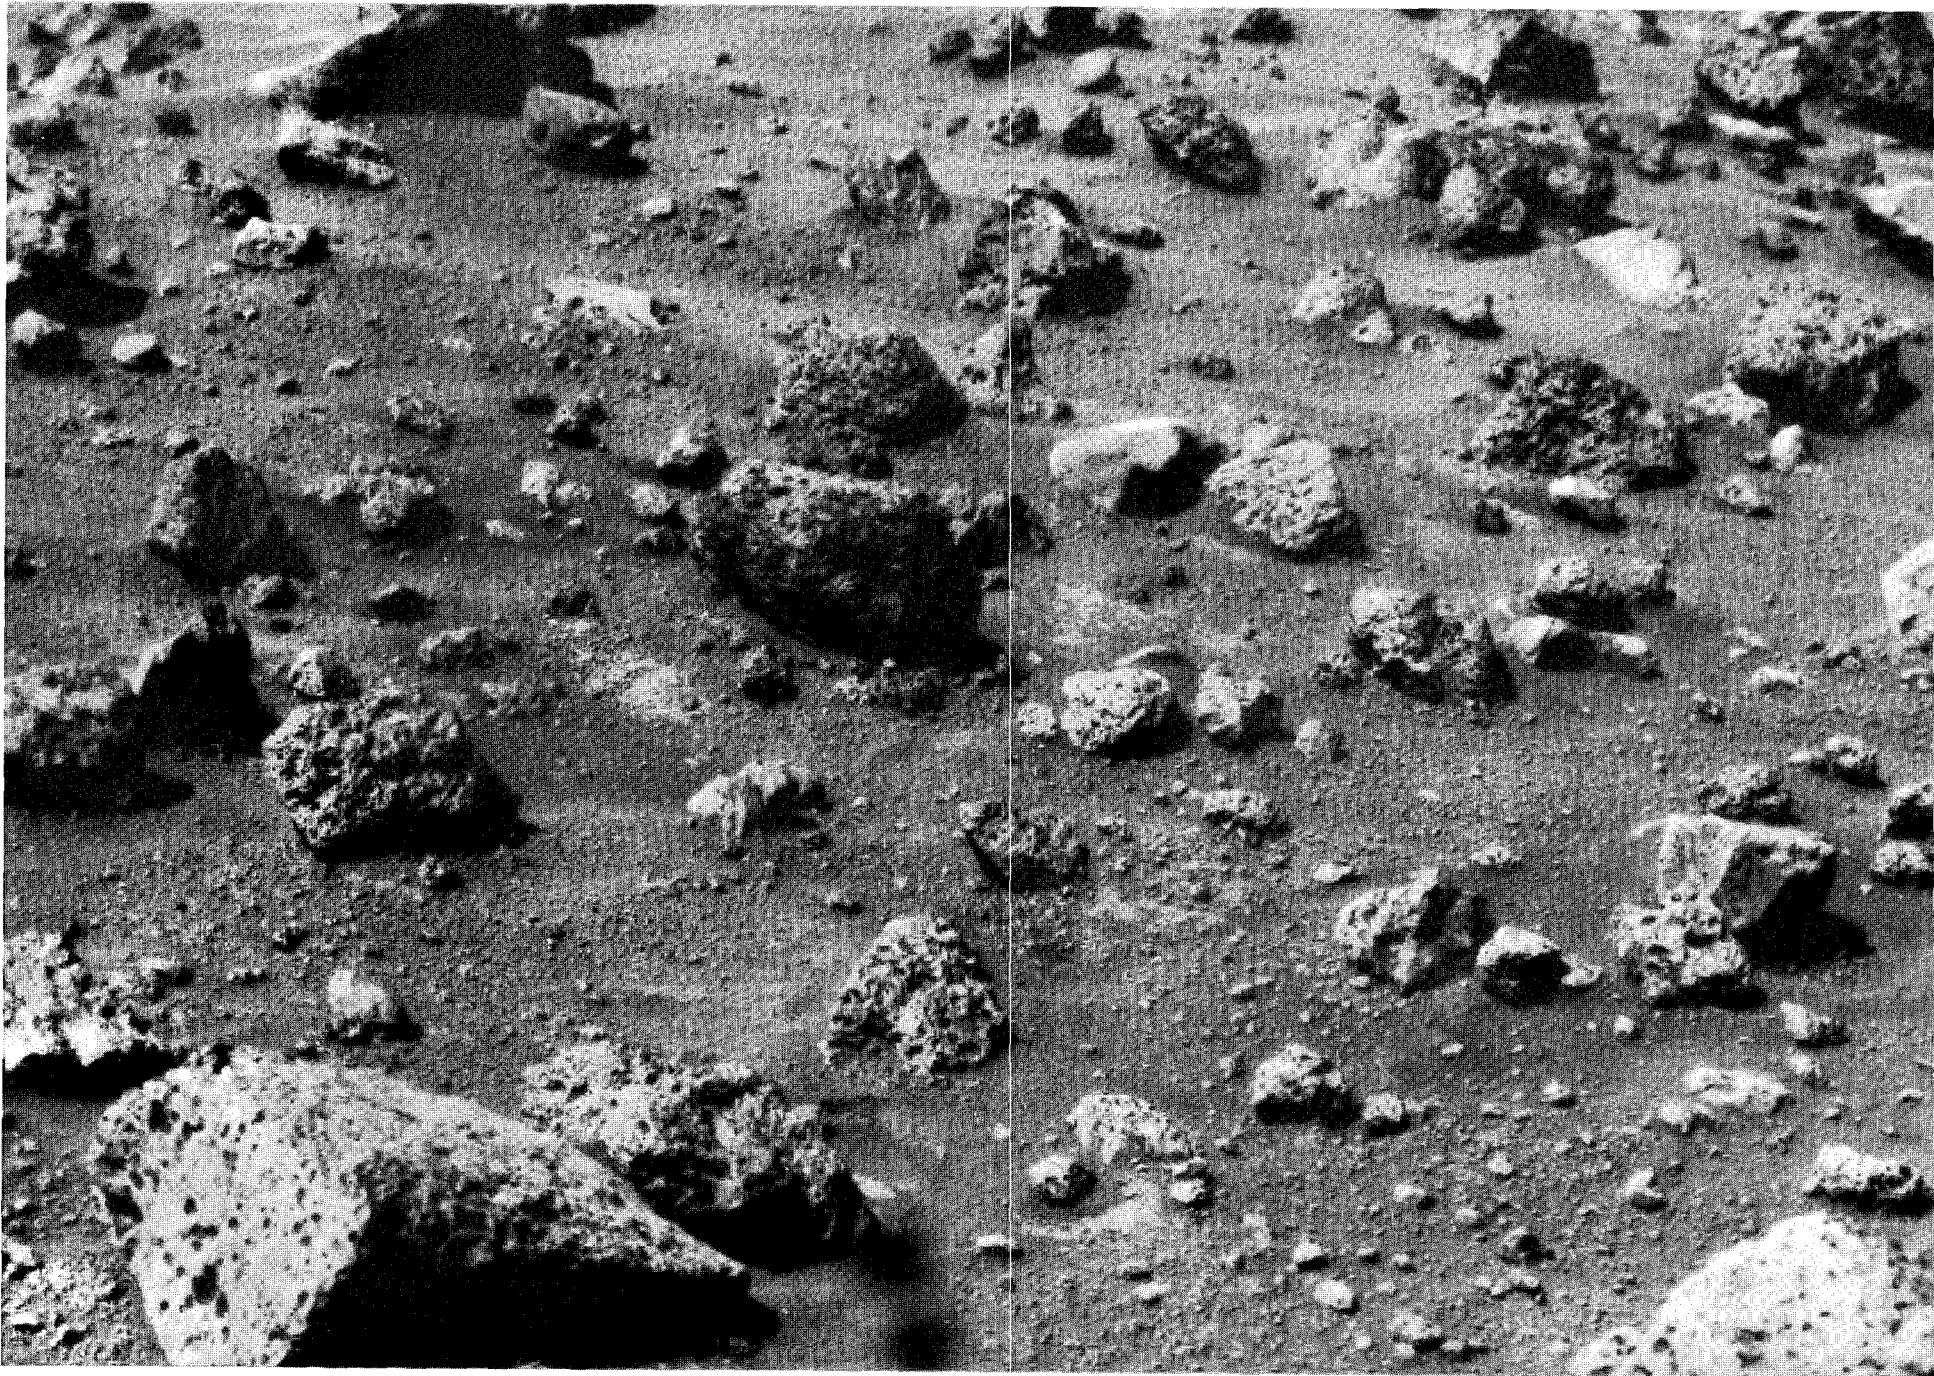
FIGURE 132

Orthogonal blocks occur throughout the scene. Some wind faceting may have occurred, but most of the blockiness is probably the result of erosion of a volcanic lava that was traversed by several sets of mutually perpendicular joints.

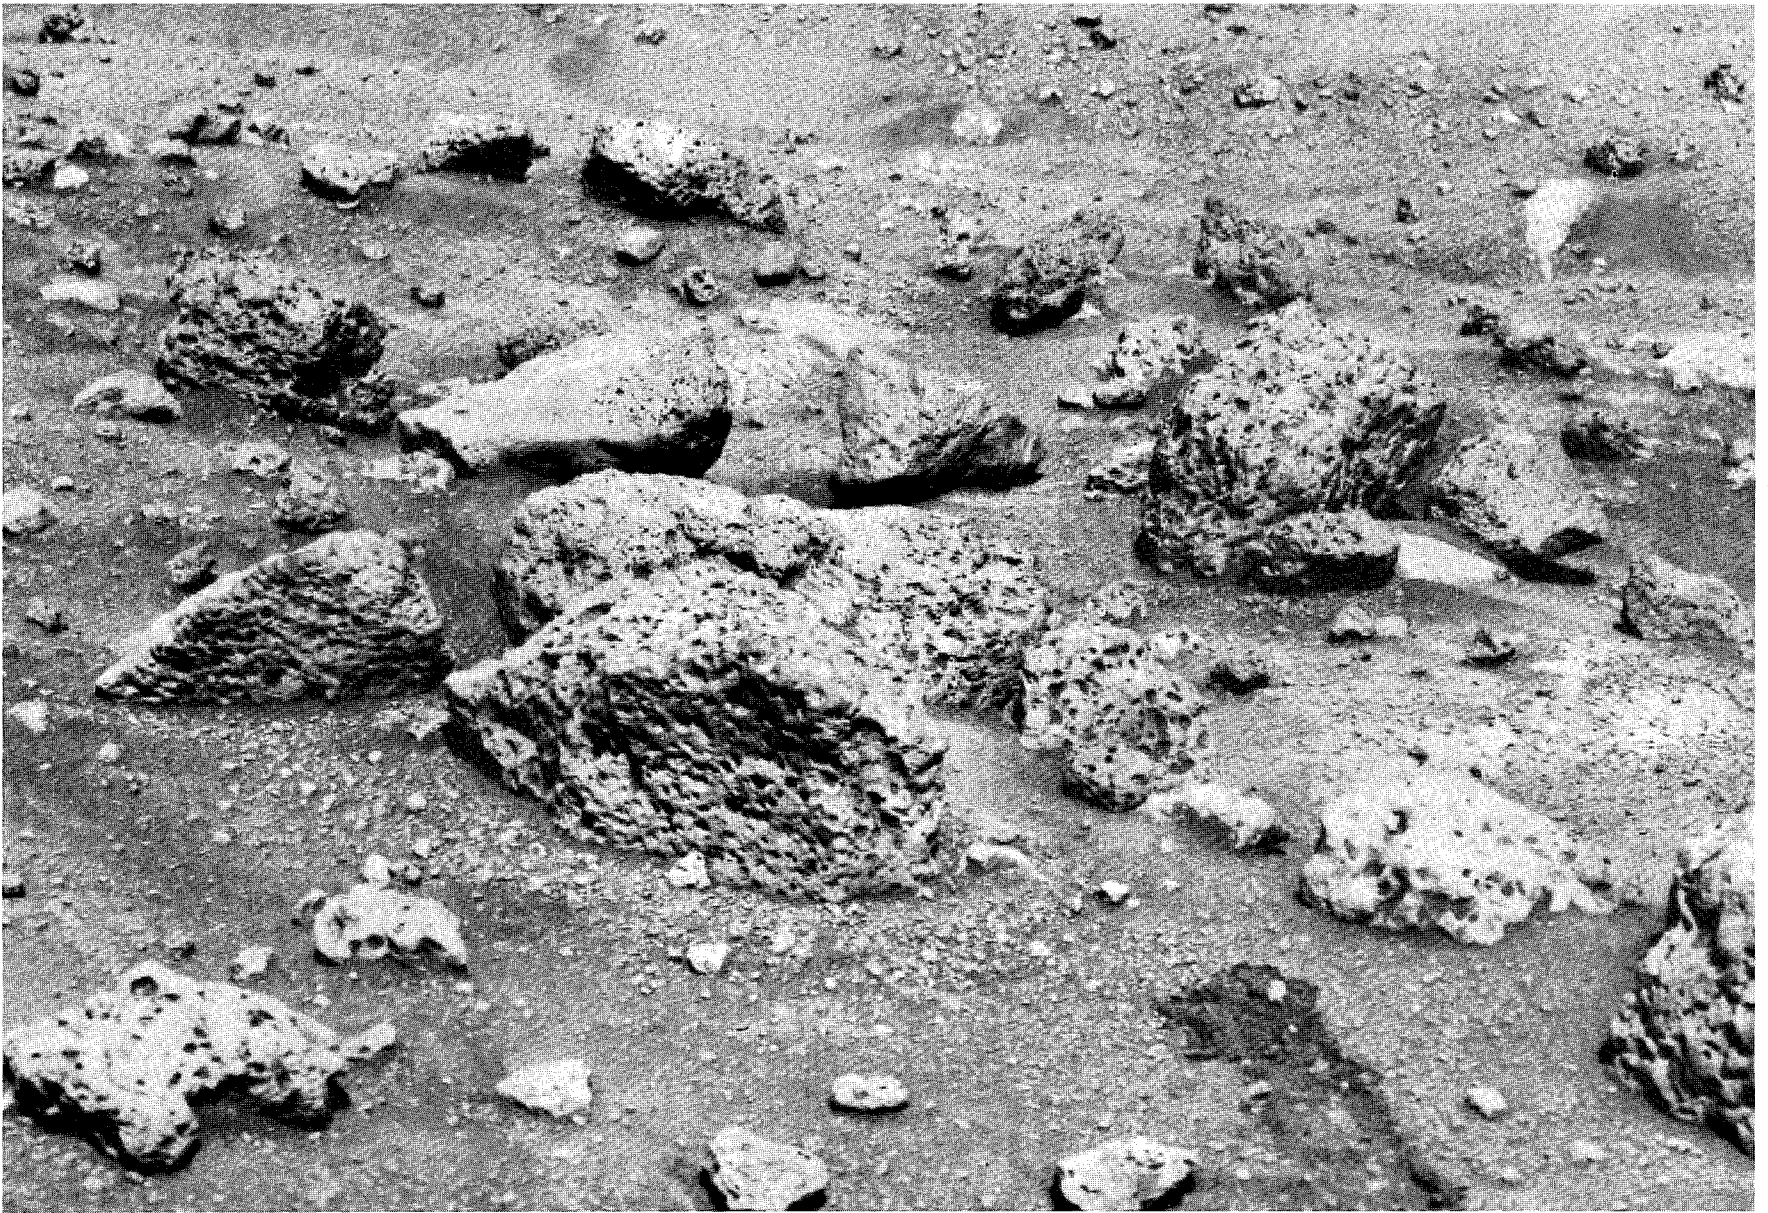
FIGURE 133

Note two boulders that occur close together a little to the left and above center in figure 133. They have matching faces which suggest that a single boulder has been split in two and the two parts separated, perhaps by frost heaving. Several of the large vesicular boulders in
